HENGELHOEF CONCRETE JOINTS

Sinus Slide® Joints

Case study: **Joint Repair**

Product: **Sinus Slide® Joint**

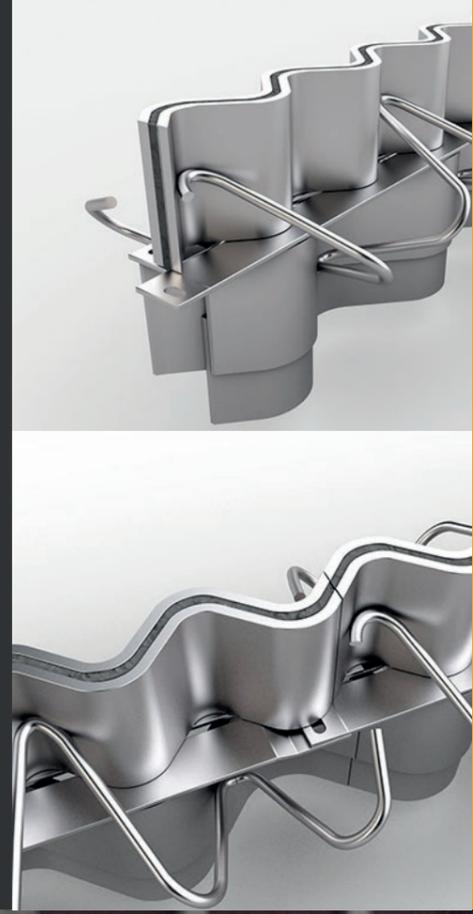
Before

In the main baggage handling area, the Brussels Airport Company is suffering from many deteriorated floor joints, that create a lot of noise and vibration when trafficked by vehicles and baggage trailers.

The main problem has been deterioration around the main movement joints in concrete overlays for the baggage handling department. Different issues have been observed and had to be taken into account for an appropriate solution:

In collaboration with the Technical Department of Brussels Airport, a specialized concrete repair company, a Chemical company providing some special self-leveling sealant and HCJ, we designed a customized solution to solve all the existing problem. It includes the necessary fire protection, an adapted reinforced and shrinkage reduced mortar and our Sinus Slide® Joint.
