## HC-Sinus Slide® Joints for lasting repairs in industrial floors

## 1. HC-Sinus Slide® repairs with jointing system

## 2. HC-Sinus Slide® Repair joint without load transfer system

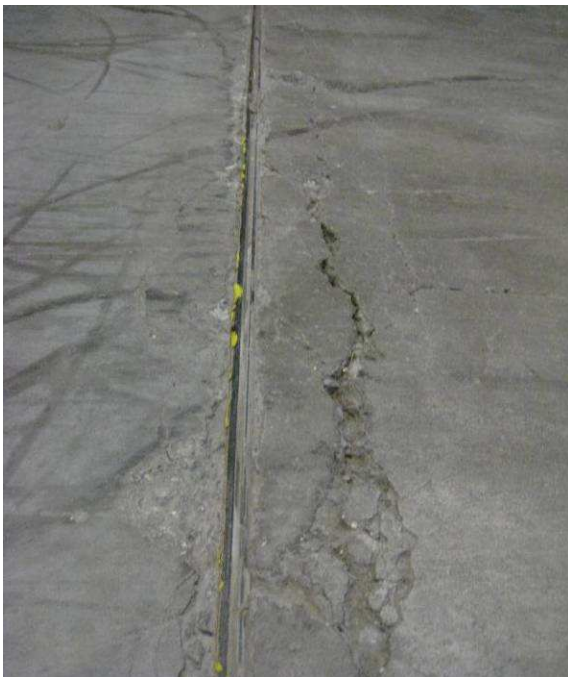
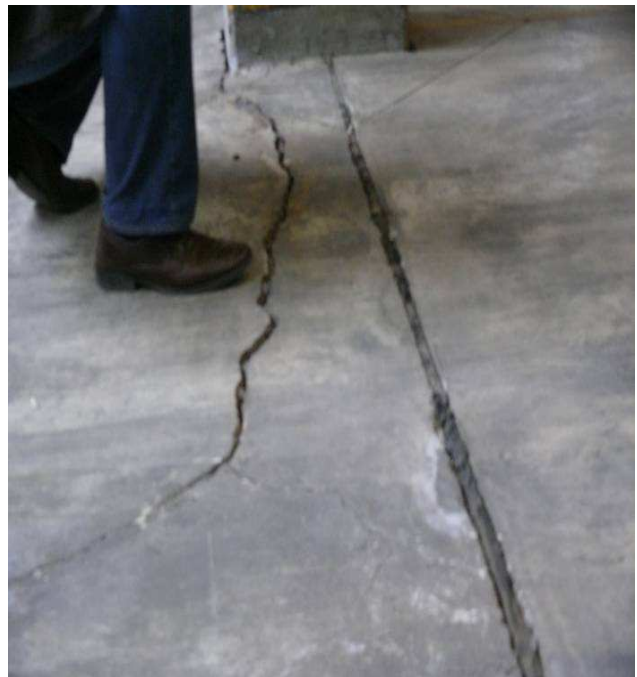
This vicious circle of damage can only be stopped by lasting repairs which neutralise the cause of damage. The cause of damage is the striking impact of the passing wheel of the forklift which will fall in the opening gap of the joint.

The solution is to create a situation where wheels are continuously supported and slide, vibration and shock free, from one floor slab to another. This is a feature of the Sinus Slide® joint, which makes them extremely useful for joint repair.

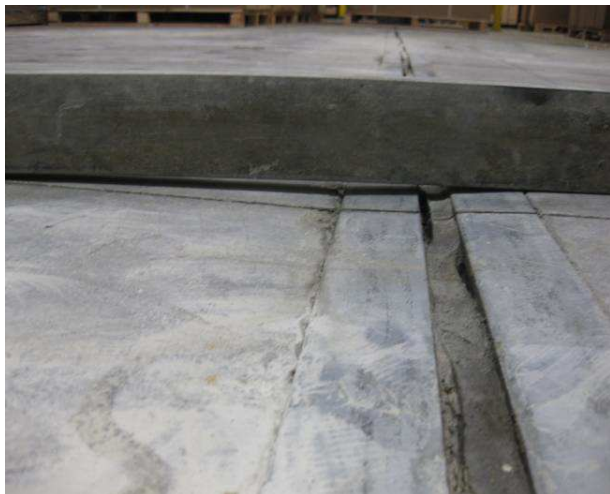
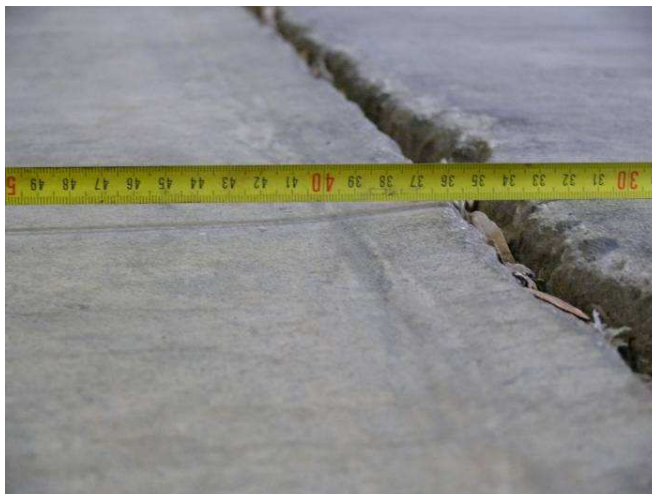
In this case the complete joint needs to be replaced or there is no joint at all between the floor slabs. The complete joints needs to be replaced if the joint is from dubious quality or there is extensive vertical displacement that a fundamental repair is the only solution. The original joint normally had the following functions.

- **Free horizontal expansion and contraction** of the industrial floor. As the poured concrete dries, the inevitable contraction is taken up by the horizontal spreading of the expansion joint. Once the dilatation process is stabilised the joint only will expand slightly by extreme fluctuating temperature. The existing joint opening is a result of the shrinkage movement of the concrete slabs. The shrinkage of a floor slab is strongly dependent on a number of thermal variables as well as the quality of the concrete. Shrinkage can vary between 0,3 to 0,5 mm/meter. In any case, an attempt must be made to limit the opening of the joints to a maximum of 20 mm. An indication in normal conditions would be floor sections of 30 to 40 metres. However, the advice of a local expert is always recommended because shrinkage can vary considerably from country to country due to local environmental factors and concrete quality. Even if shrinkage and cracks are under control there is another problem which can be a source of annoyance, lead to uncomfortable and unsafe work stations and significant costs. That problem is the straight traditional joint opening gap.

- **Load transfer and the limit of any vertical movement.** The construction of the joint ensures the floor slabs are connected and that any vertical movement is limited. This principle enables also to realize the necessary load transfer which gives much better support of the slab and extends its life.

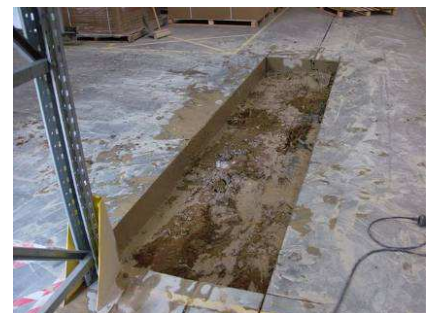
**Saw-cut the concrete full depth on both sides of the damaged joint on a width of approximately 800 to 1000 mm. Remove carefully the concrete and re-level and re-compact the sub-base material.**

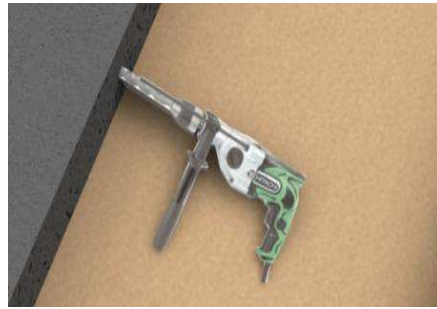
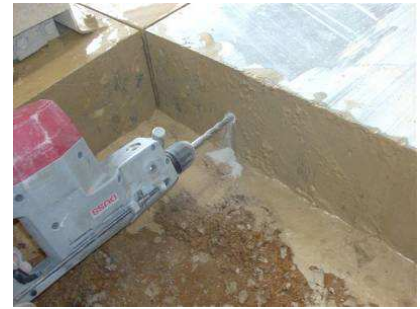
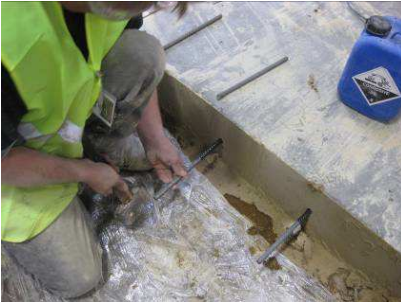
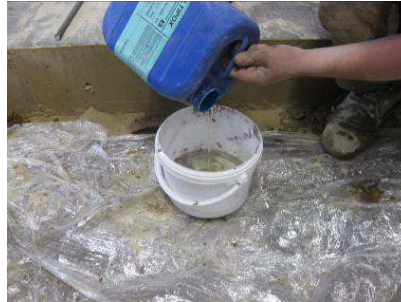
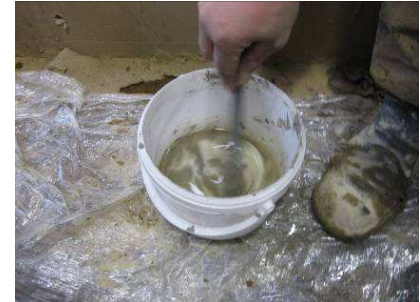
Then drill and fix deformed bars ( $\varnothing 16 \times 600$  length) in each concrete slab. At least 3 dowels per meter in each concrete slab. 300 mm of the dowel must be fixed in the concrete (ideally with resin anchorage system) and 300 mm must stick out. Apply special primer on all vertical sides of the concrete slab.

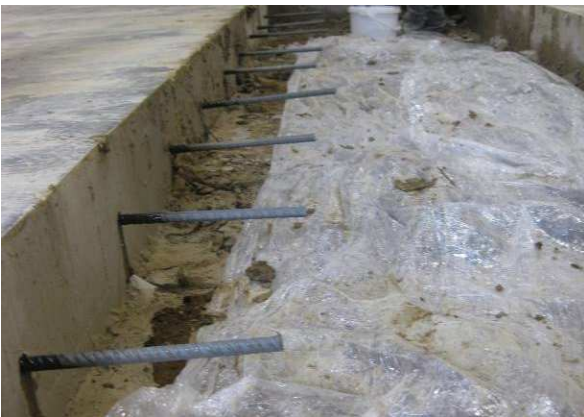
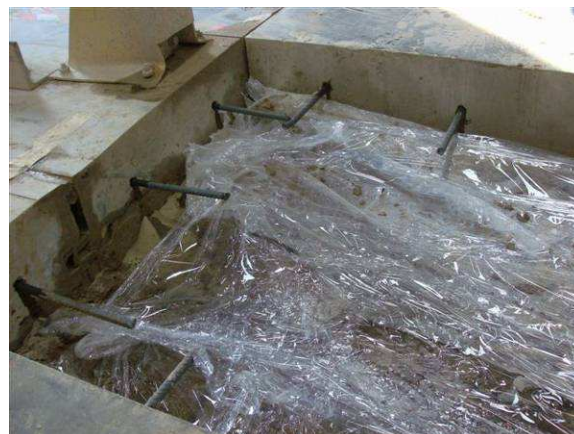
Install a HC Sinus Slide® joint in the middle of the gap opening between the concrete slabs. Level out the HC Sinus Slide® joints down and across. Eventually, weld the dowels fixed in the concrete slabs to the anchorage system of the HC Sinus Slide joint or use reinforcing mesh to link dowels and joint connectors.

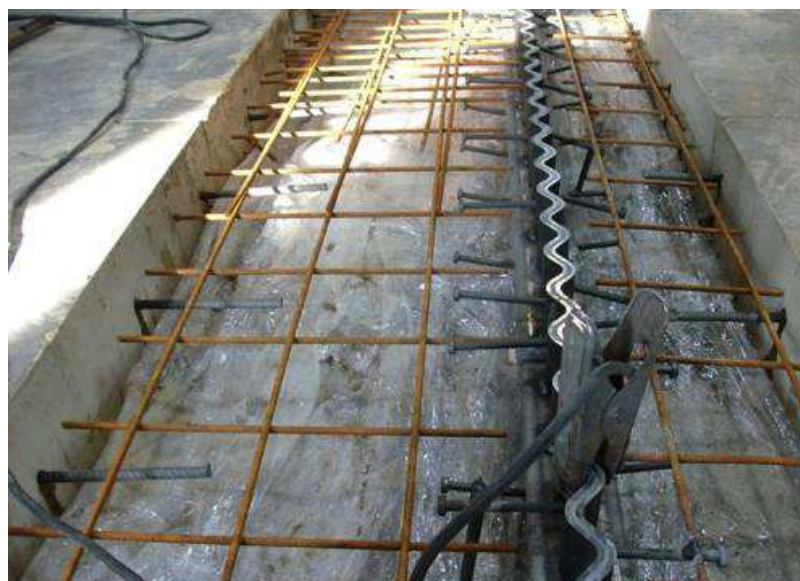
Fill up the opening gap with (reinforced) concrete or special repair mortar. Finish the floor by polishing and/or grinding. It is recommended to use a HC Sinus Slide® joint with minimum 5 mm foam in-between the 2 half's to permit a horizontal movement in the two directions in case of extreme temperature changes. This repaired jointing system with sliding capacity will realise optimal smooth load transfers by 100% shock- and even vibration free wheel crossings. Future damage is almost impossible and unprecedented comfort is achieved. Yearly savings on forklifts wheels maintenance or replacement are substantial.
